RESERVE STUDY

Great Falls Woods Homeowners Association

Great Falls, Virginia
December 17, 2020

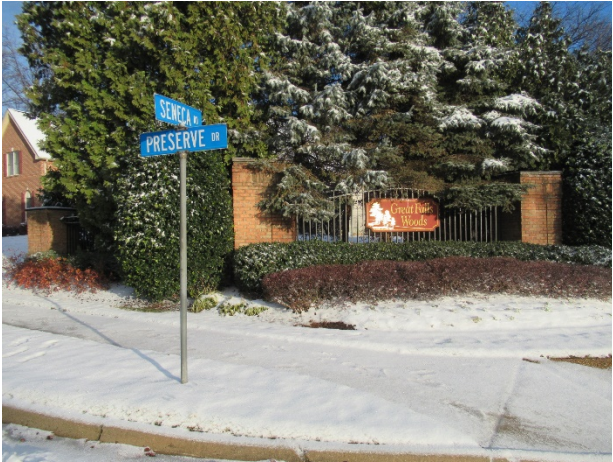
Condition: Good to fair overall with masonry stains and minor fence rust evident

Entrance monument overview

Useful Life: We recommend renovations of the entrance monuments every 15- to 20-years

Expenditure Detail Notes: Expenditure timing and costs are depicted in the **Reserve Expenditures** table in Section 3. Our cost for renovation includes repointing and repairs to the masonry, landscape enhancements, and replacement of the remaining components listed above.

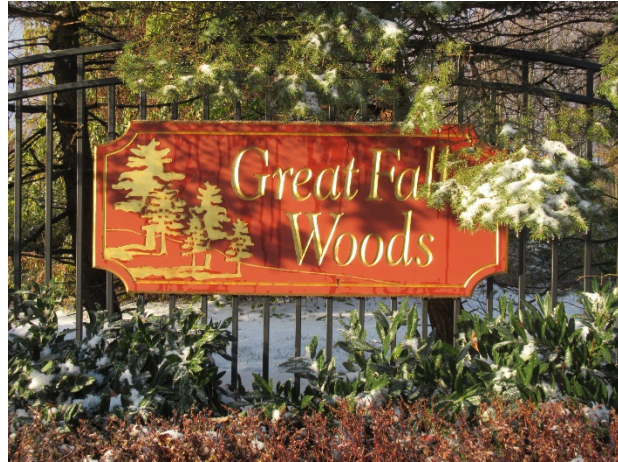
Wood signage

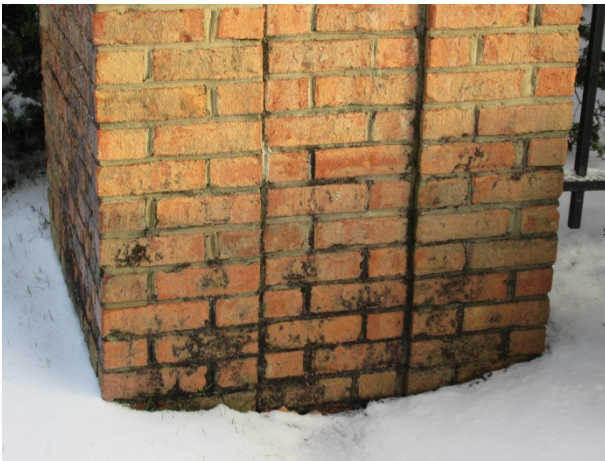
Masonry stains

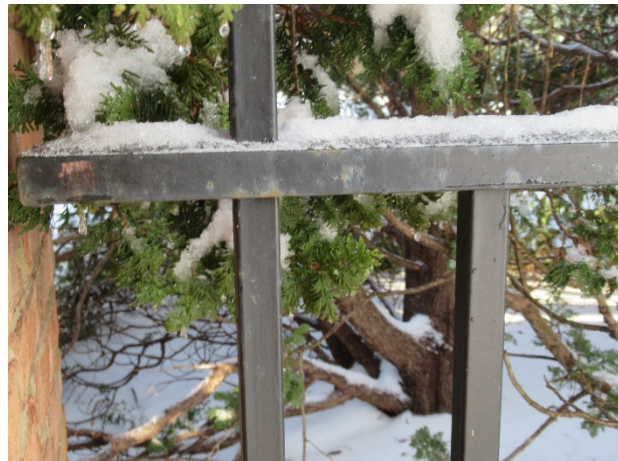
Minor fence rust

- Annually:
 - Inspect and repair damage, vandalism and loose components
 - Verify lighting is working properly
 - Touch-up paint finish applications if applicable
